**REPAIR OF BIOMEDICAL EQUIPMENTS UNDER BIOMEDICAL EQUIPMENT
MAINTENANCE PROGRAM (BEMP)**

Recommendations for Beyond Economic Repair (BER)

Service Report

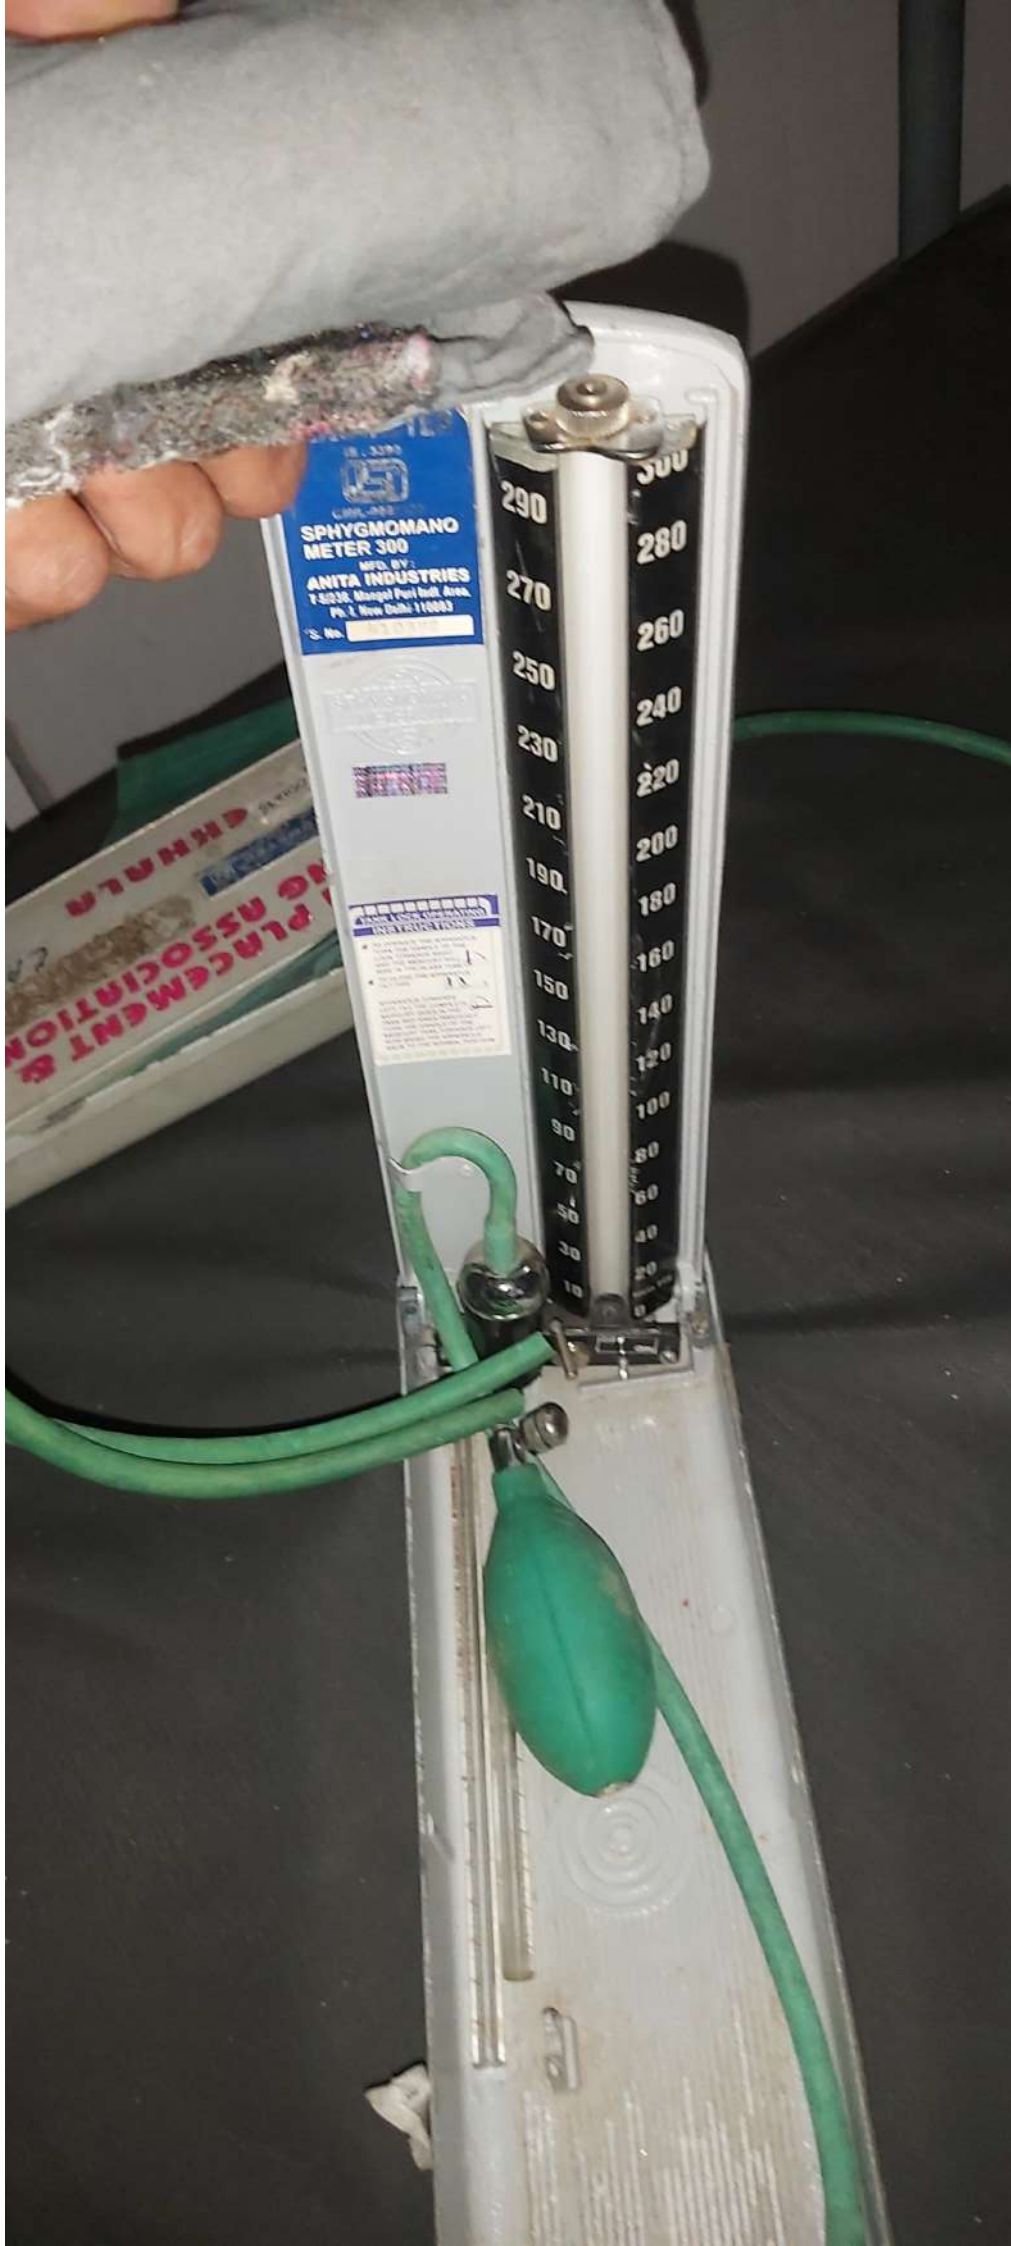
Problem Identified : BP hinges slot damaged, Glass tube broken, Mercury lost, Bladder leak, BP bulb with valve required.

Action Taken : Checked. Machine is totally damaged condition. Required BP glass tube, BP bladder, BP bulb with valve, BP connector and mercury. Economically not repairable.

Customer Remark Machine fully in damaged condition. Completed Pending
SINDHU.K.K
Senior Nursing officer.

Asset value - 2333
 Cost of Spare = 1750 (75%)
 Life Period - 4 year 10 months
 As per the BER guidelines recommend as
 BER
