### REPAIR OF BIOMEDICAL EQUIPMENTS UNDER BIOMEDICAL EQUIPMENT MAINTENANCE PROGRAM (BEMP)

### Recommendations for Beyond Economic Repair (BER)

### 5426ZG032123 - CENTRIFUGE 5415R 230V/50-60Hz

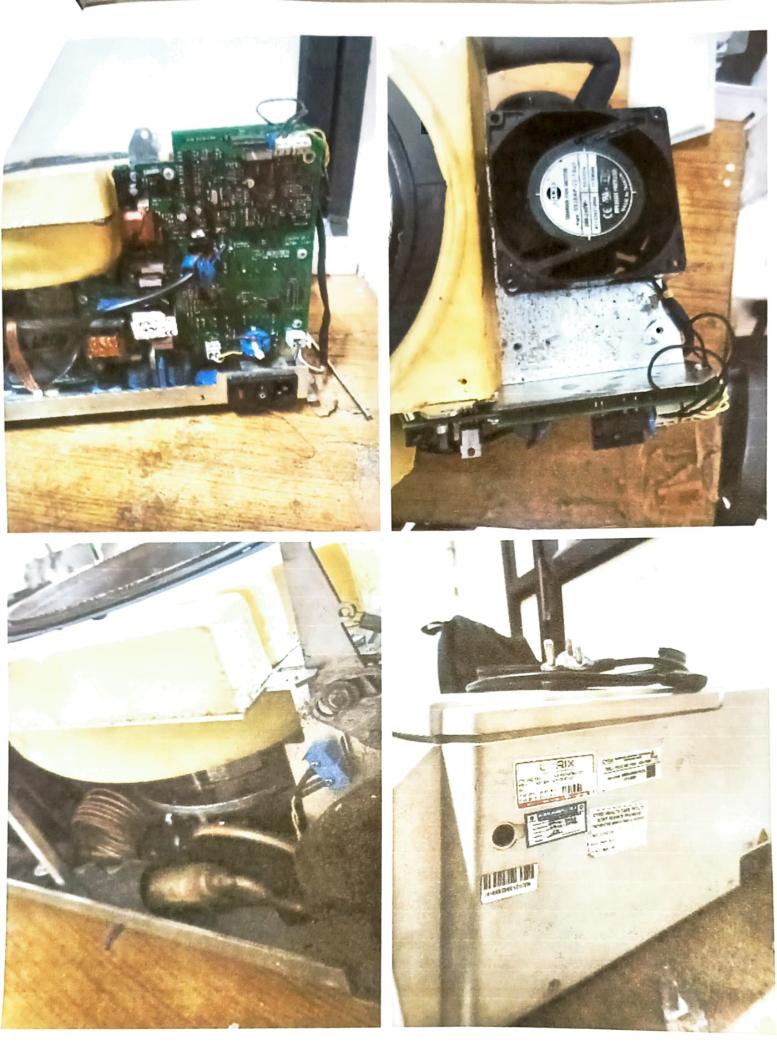
## \* Attach Photograph

Remarks and Recommendations of Junior Consultant (Biomedical) NHM: PCB Board is faulty. Spare parts not available as machine is obsolete. So can MANEESHA MOHAN M.R. he RBGR. Junior Consultant (Biomedical) National Health Mission Thiruvananthapuram -1-2024 Signature of JC BM (NHM)

Field Instrument Repair Service Engineer Kumar, Sudhi Suresh Checked and found Input supply is fine and centrifuge not switching on. In further observation found power supply 230v till pcb converter, but no outpt fro PCB convertor is faulty. As the equipment is obselate we cant provide any further s Kindly go for a buyback of centrifuge.	Service Date m PCB. pare support.	12 Jan 2024
