**REPAIR OF BIOMEDICAL EQUIPMENTS UNDER BIOMEDICAL EQUIPMENT  
MAINTENANCE PROGRAM (BEMP)**

**Recommendations for Beyond Economic Repair (BER)**

**Service Report**

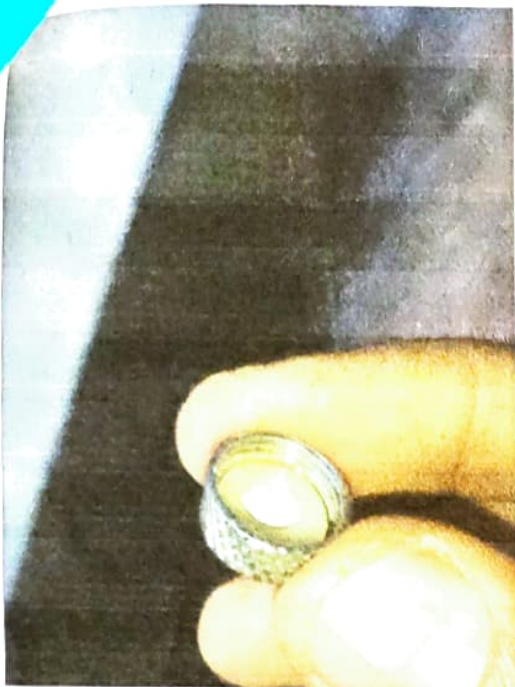
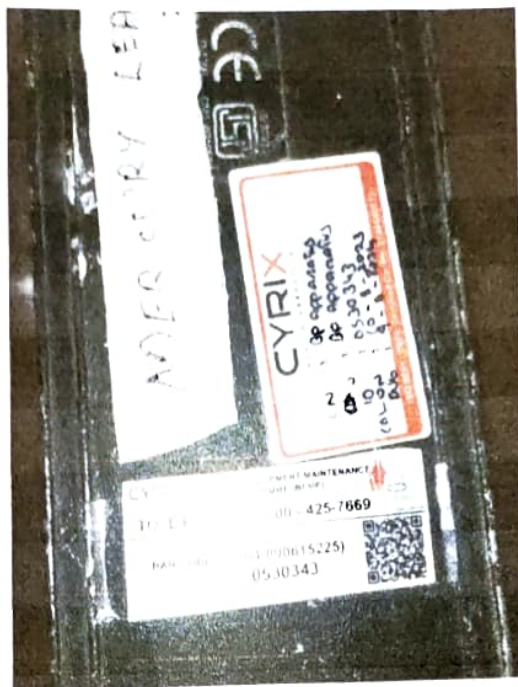
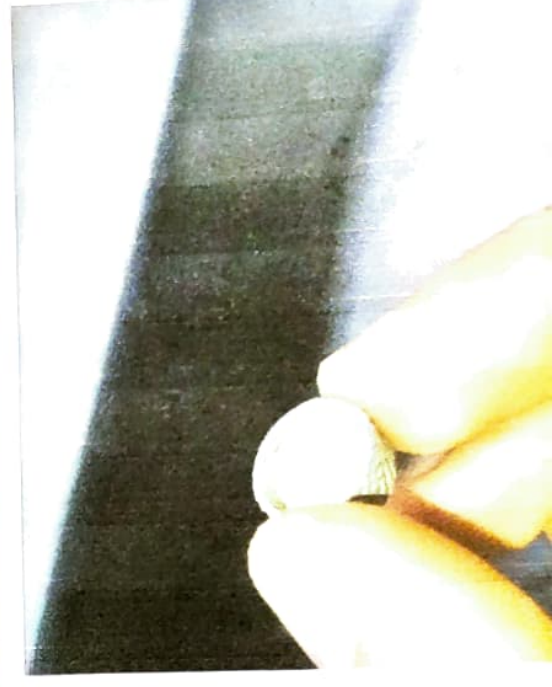
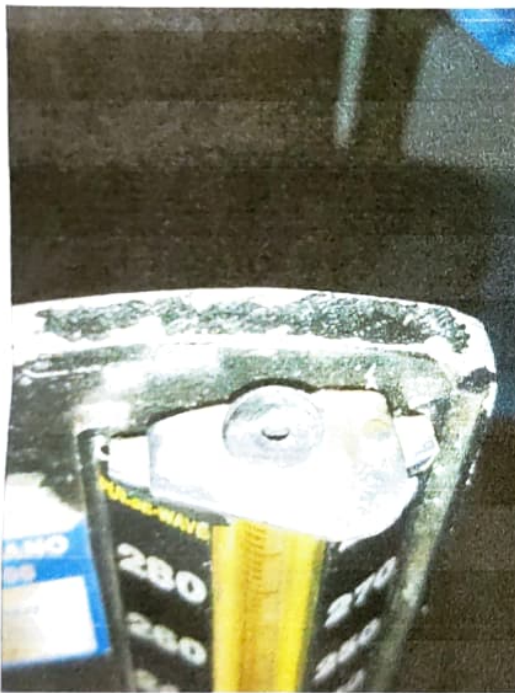
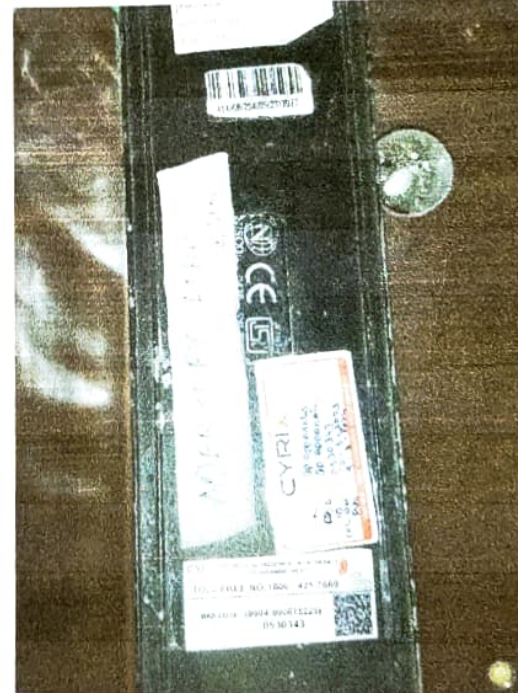
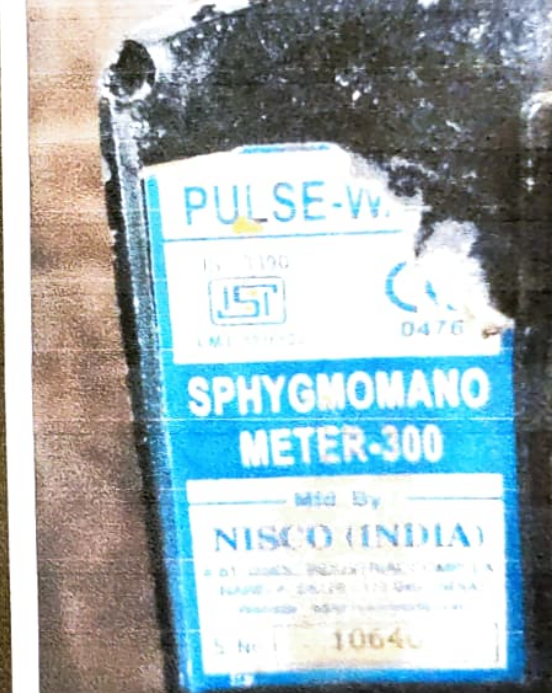
\* **Attach Photograph**

13	Asset Value	1323
14	# Percentage value of the cost of spares with respect to Cost of Purchase/ Asset Value	NA
15	Abstract of Service Report provided by the OEM/ Authorized Service Provider/ CYRIX (Attached or Not)	Cyrix
16	Reasons for recommending the equipment as BER	Top filter cover unrepairable Spare part not available. Machine is very old & mercury spillage is very high. Machine is hazardous to users.
17	Name & Signature of CYRIX Authority	Nidhish Roy <u>NDR</u>

**Problem Identified :** Mercury leakage issue.

**Action Taken :** Checked Mercury lost. Tap cover cracked and not fit to machine. This part not available. Damaged cover not repair and reuse condition. So that machine is unserviceable condition.

Asset value = 1323  
 Cost of spare - not available  
 Life period - 14 years ~~and above~~ & above  
 machine fully damaged and mercury spillage is high.  
 As per the RBER guidelines recommended  
 as RBER
