**REPAIR OF BIOMEDICAL EQUIPMENTS UNDER BIOMEDICAL EQUIPMENT
MAINTENANCE PROGRAM (BEMP)**

Recommendations for Beyond Economic Repair (BER)

Service Report

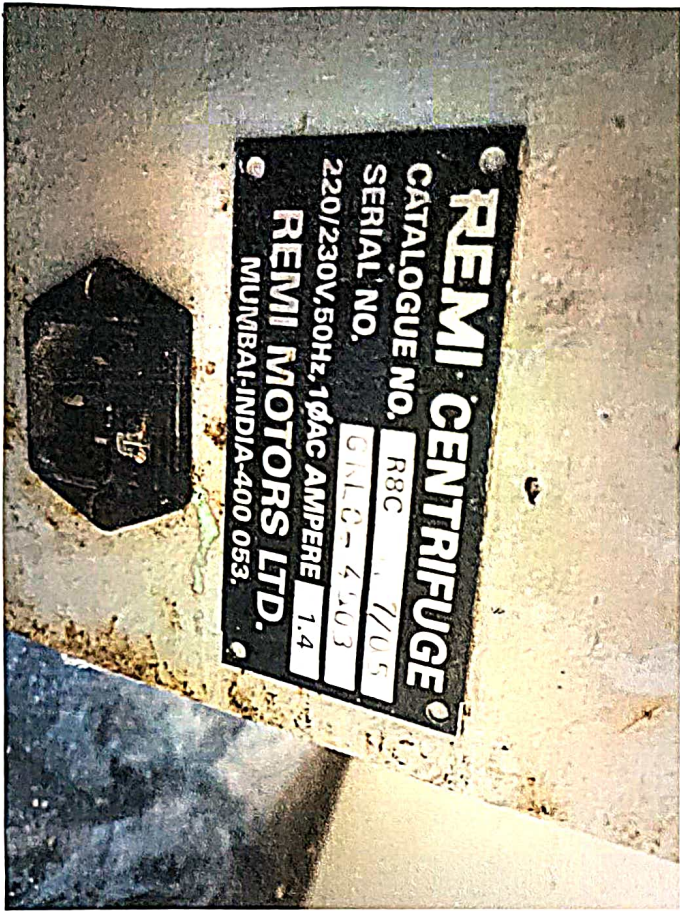
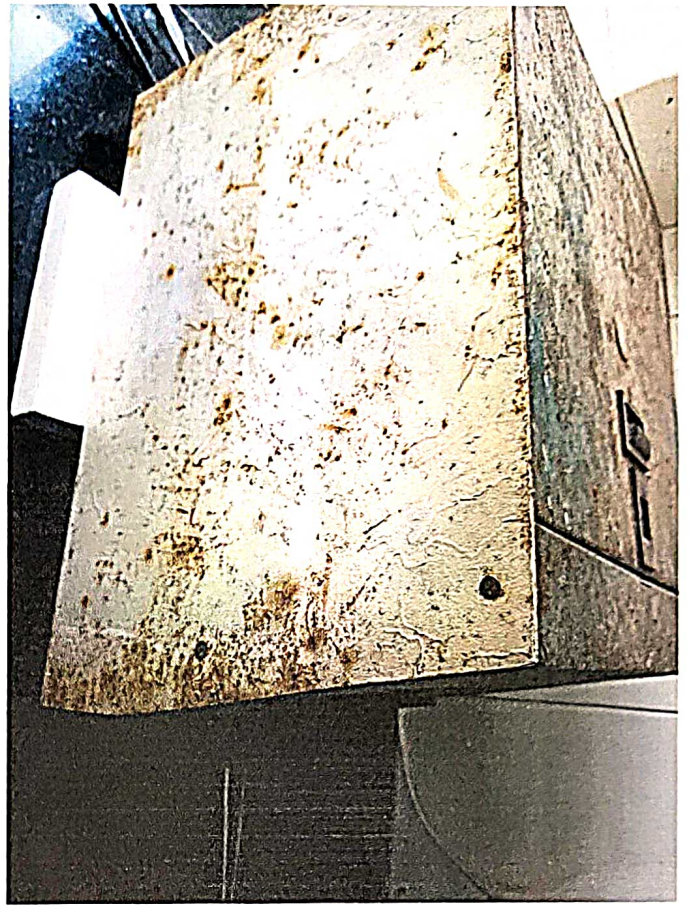
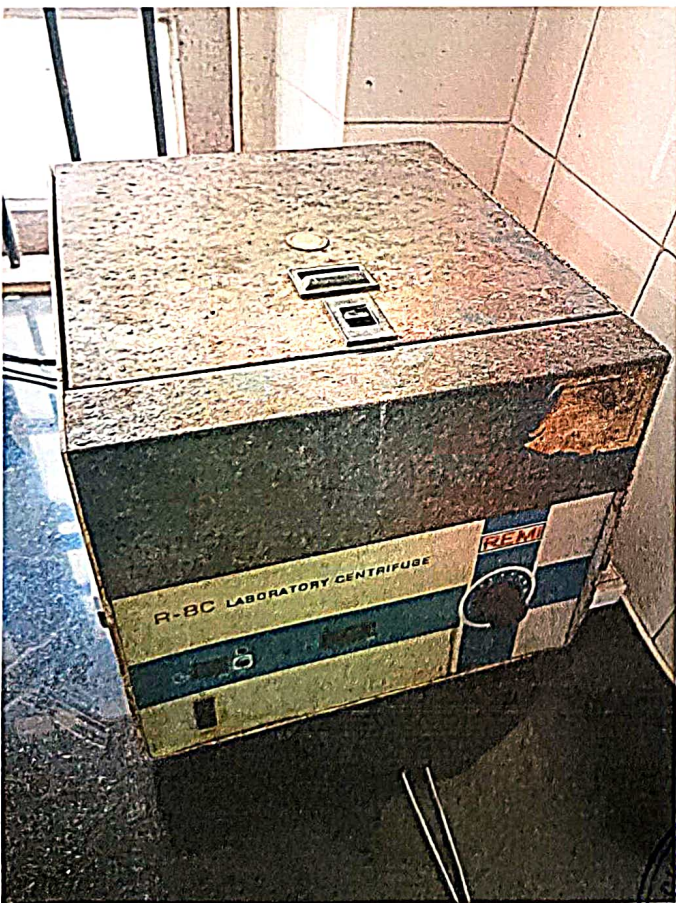
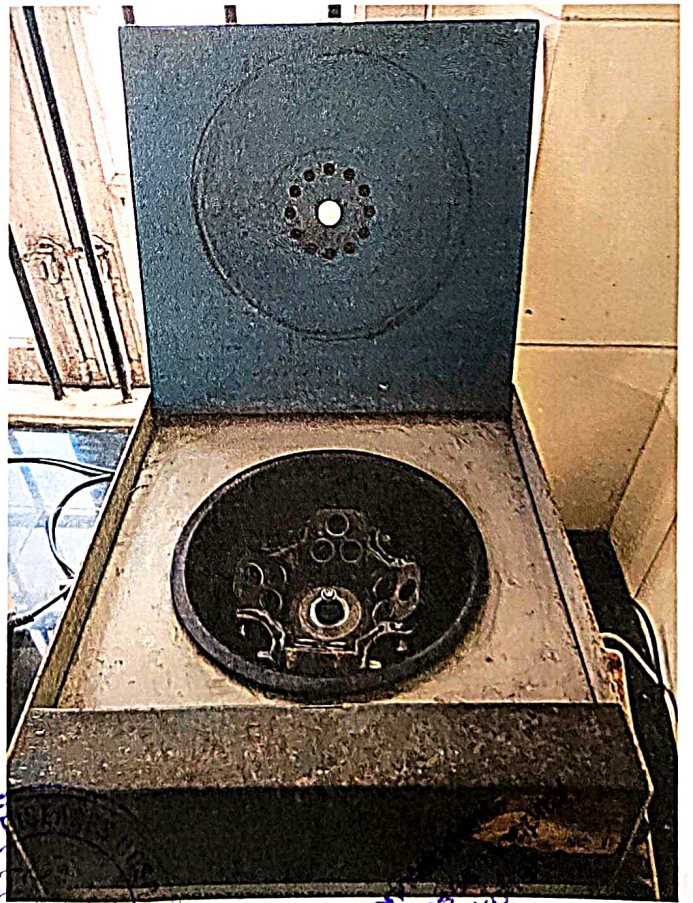
Action Taken : Checked the machine. problems found in the motor side and body side. Motor is damaged and the transformer is faulty. Need to replace the motor, carbon brushes and the transformer. The equipment body is completely rusted.

REMI CENTRIFUGE
CHALLENGE NO. RSC 4/0
SERIAL NO. 1830 AMBERG 314
REMI MOTORS LTD.
MUMBAI, INDIA - 400 753

CYRIX MEDICAL EQUIPMENT MAINTENANCE
TOLL FREE NO-1-800-425-7669
SAR CODE - (8004-890615225)
0714376

Transformer and Speed regulator with motor fully defective. So can RBER.
