**REPAIR OF BIOMEDICAL EQUIPMENTS UNDER BIOMEDICAL EQUIPMENT
MAINTENANCE PROGRAM (BEMP)**

Recommendations for Beyond Economic Repair (BER)

BIOMEDICAL EQUIPMENT MAINTENANCE PROGRAMME UNDER NATIONAL HEALTH MISSION

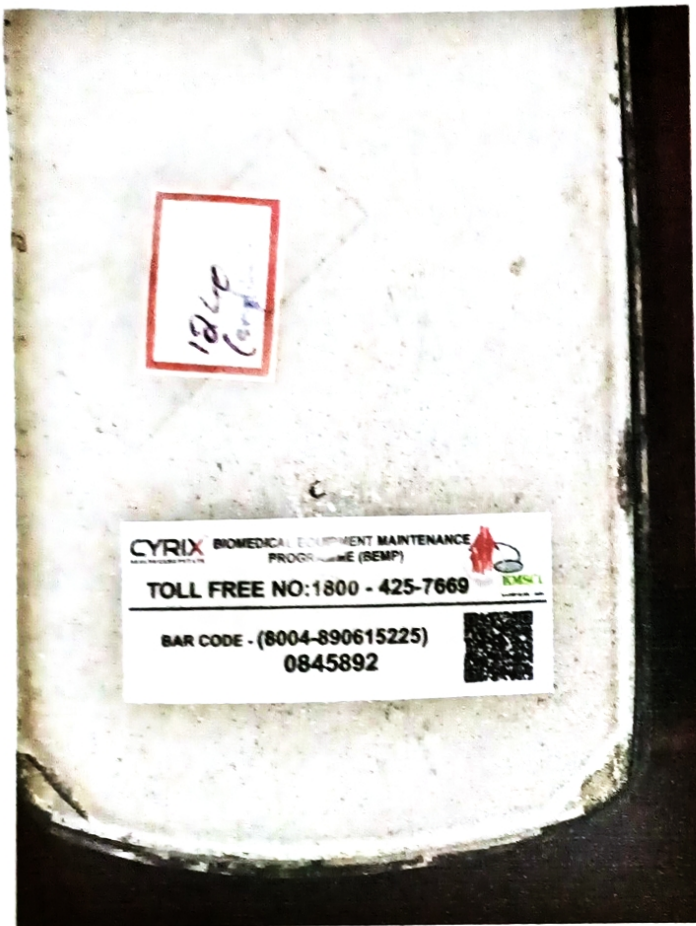
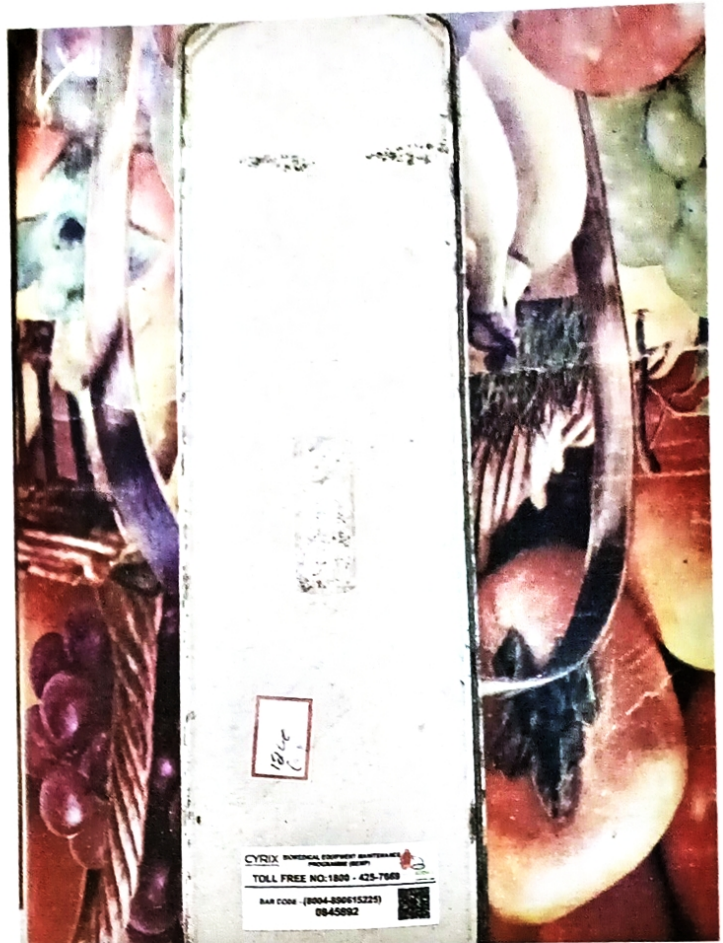
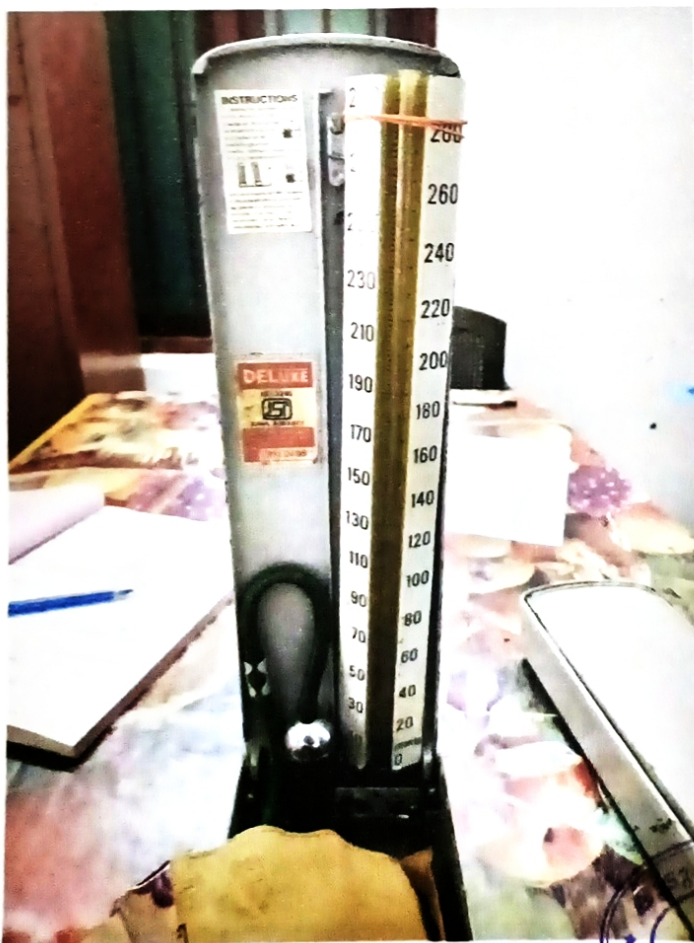
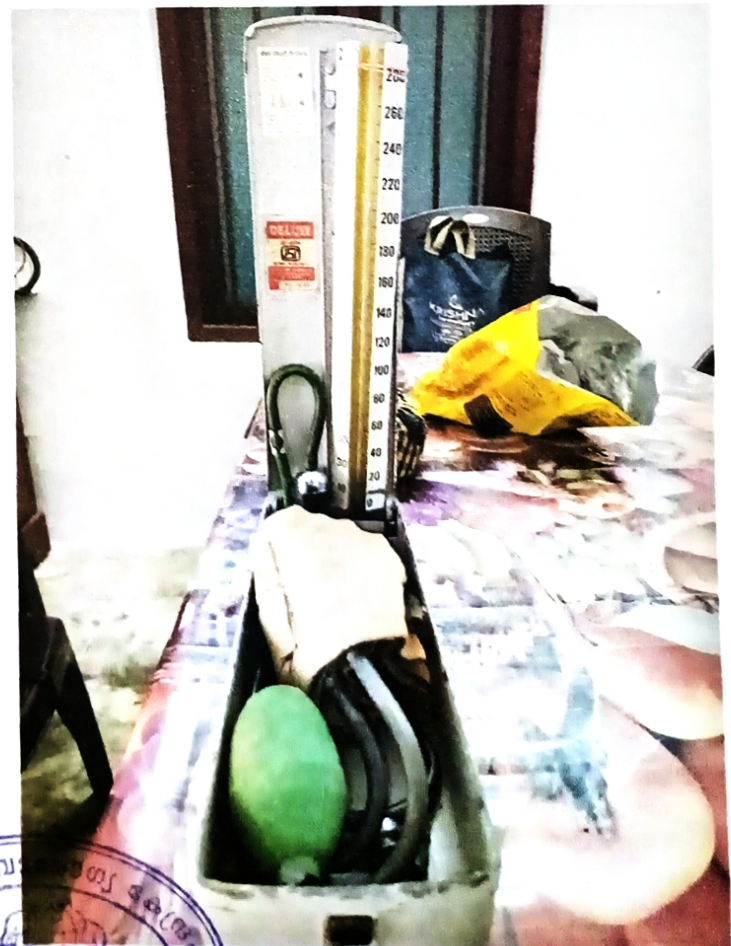
* Attach Photograph

Spare cost is high as the broken glass tube, mercury to be refilled

Problem Identified : pressure not rising

Action Taken : checked the equipment and found Mercury tank and glass tube broken, need to replace glass tube, Mercury tank and need to re-fill mercury

13	Asset Value	1,323/-
14	# Percentage value of the cost of spares with respect to Cost of Purchase/ Asset Value	69.54%
15	Abstract of Service Report provided by the OEM/ Authorized Service Provider/ CYRIX.	Cyrix Service report, quotation attached
16	Reasons for recommending the equipment as BER	Checked the equipment and found mercury tank and glass tube broken, need to replace glass tube, mercury tank and need to refill mercury. Equipment installed on 14/02/2019 and covered up to 5 years and 5 months, Spare cost is 69.54% of asset value both criteria for RBER met. As per tender clause 5.3.14.1 we recommending the equipment for condemnation.
17	Signature of CYRIX Authority	BIJO T JOY
