**REPAIR OF BIOMEDICAL EQUIPMENTS UNDER BIOMEDICAL EQUIPMENT
MAINTENANCE PROGRAM (BEMP)**

Recommendations for Beyond Economic Repair (BER)

Sl. No	Particulars	Details
1	Name of District	KANNUR
2	Name of Hospital	CHC MATTANNUR
3	Name of Equipment with Make, Model and Serial Number	BP APPARATUS Make: BEURER Model: BM27 SN: NA
4	Equipment ID/ Barcode	1330253 #130551
5	Date of purchase/ Year of manufacture/Installation Date	In ticket master installation date 11.03.2022 As per stock book Installation date is 24.04.2018 (Stock book copy attached for reference)
6	Warranty details (Yes/No)	No warranty
7	*AMC/ CAMC Period agreed at the time of Purchase	No AMC/CAMC
8	Date of breakdown (Date of registration of complaint through email/ Toll free)	Toll free 21.08.2024
9	Action taken	Checked the Equipment found Equipment is not switching ON, found that Main Board, Pressure sensor and Display Defective. Need to replace these spare for further checking.
10	Present status of the equipment (Fully damaged / partially damaged)	Fully damaged
11	Recommendations for repair (required service details)	No recommendations

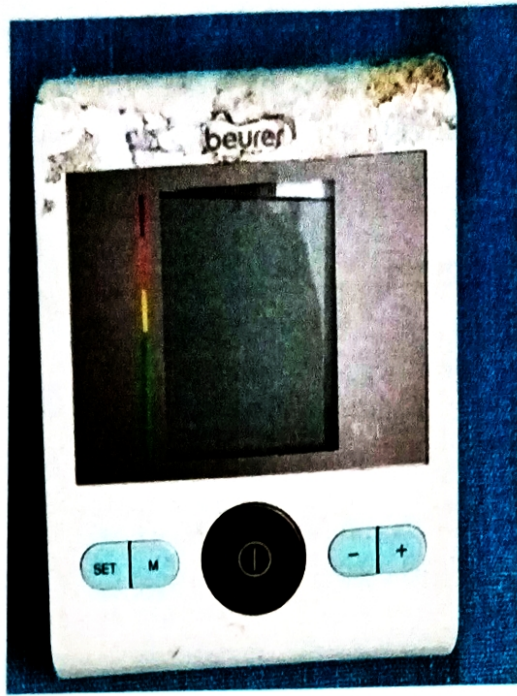
**BAR CODE - (8004-890615225)
1330253**

checked & identified that machine not switching ON, due to main board, pressure sensor, display are defective. need to replace with new spare. The spare cost economically not feasible. Aged up to 6 years & above. So recommended for BER as per BER Protocol.

Problem Identified : equipment is not switching on

Action Taken : checked the equipment and found equipment is not switching on, found that main board, pressure sensor and display defective. Need to replace these spare for further checking
